# JERSEY CITY RESERVOIR NO.3 DAM

## PHASE I INSPECTION REPORT NATIONAL DAM SAFETY PROGRAM

NJ 00524

JERSEY CITY RESERVOIR NO. 3 DAM (NJ00524)

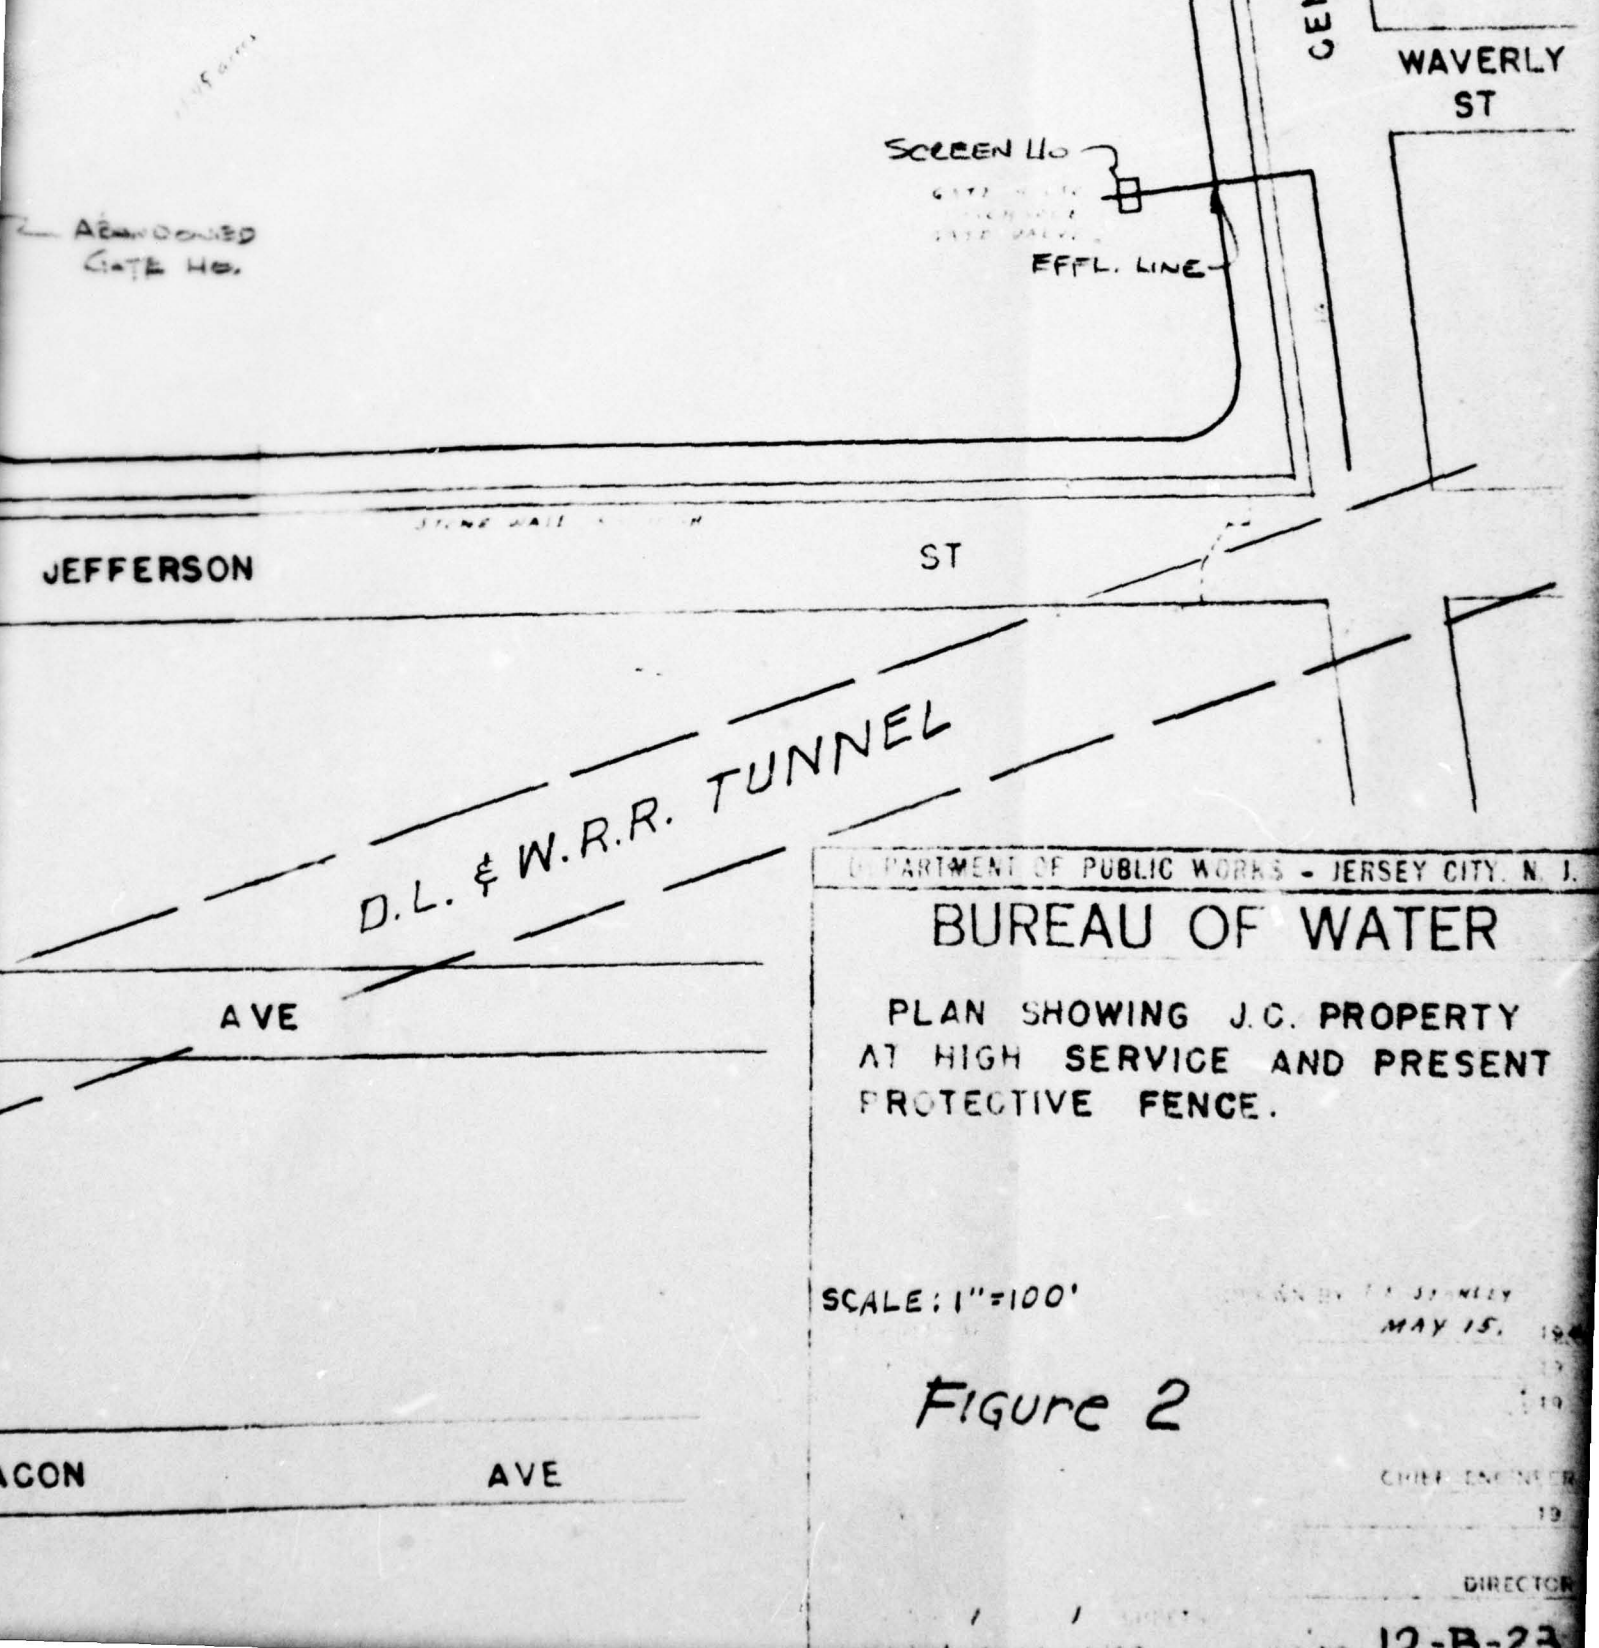
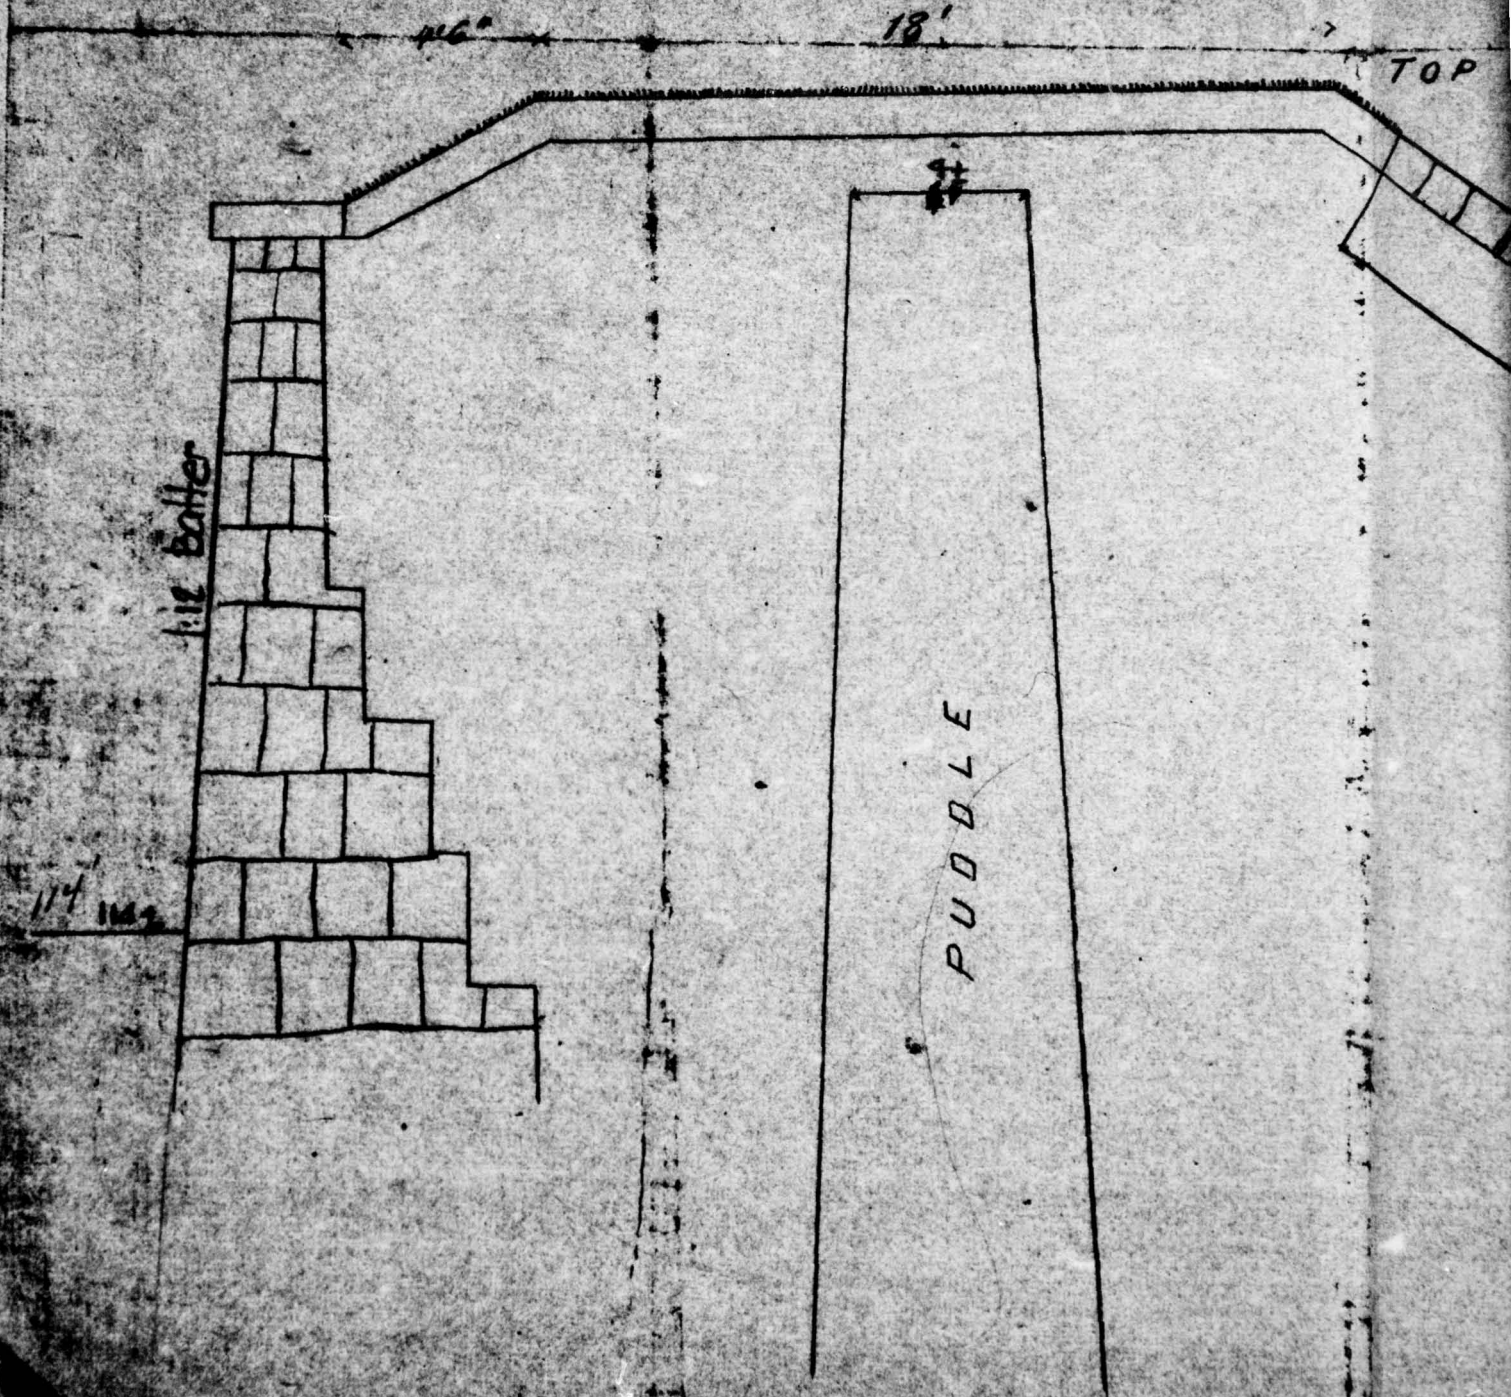
SECTION OF  
*Easterly Embankment of Reservoir No.*  
*Jersey City N. J.*

Review of the one structural (see Figure 3) and two construction drawings indicates that the design appears to have been consistent with the prevailing state-of-the-art at the time of construction. The design and construction of the reservoir has obviously withstood the test of time and field inspections indicate that the reservoir was well built and the walls appear to date, to be structurally sound. However, the available data is considered inadequate for design review and further investigations are required to ascertain the physical conditions and assess the structural stability of the entire perimeter wall system.

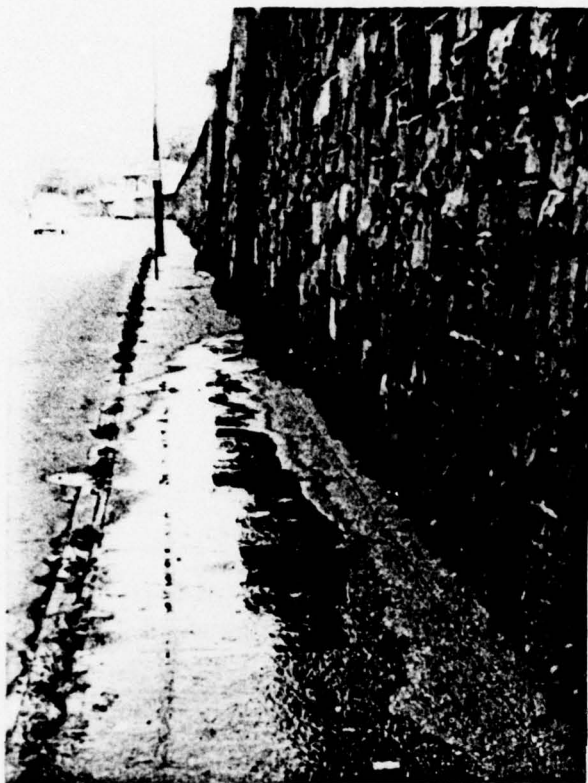
The exterior walls of the Reservoir appear to be in fair condition. Alignment and plumbness of the walls are quite true and only superficial mortar cracking was noted. A slight leak or seepage was observed one foot above the sidewalk level near the southwest corner of the west wall on Summit Avenue. Communication with City personnel on duty indicates the leak is approximately at elevation 123 MSL and has existed unchanged for several years. The reservoir was reportedly lowered some 5 years ago and an inspection of the riprap surface near the leak was performed by personnel of the engineering department of Jersey City. No corrective action has been taken since that inspection. Copies of the inspection report were not located in the City records.

Minor seepage was noted at the base of the west wall on Summit Avenue which confirmed the existence of a leak in the vicinity. Water level in the reservoir at the time of the inspection was at elevation 121.5, about 1.5 feet below the reported elevation of the leak. Thus, no assessment could be made with respect to the magnitude of the leak at normal pool elevation although reputedly, it is minor in nature.

LEAK AT WEST WALL

Jersey City Reservoir No. 3. Further investigation and evaluation of the leak and riprap settlement at the west wall is recommended and some form of corrective action such as grouting or repositioning of the riprap should be undertaken based on the results of the investigation. It is further recommended that the City of Jersey City evaluate their own requirements for an internal alarm system to alert operators of a possible or impending failure. A system of this nature may take the form of an automatic water level recorder with an alarm system to indicate rapid changes in water elevation. In conjunction with an operator's alarm is the requirement for a community warning system to alert residents in the surrounding area of hazardous conditions. This system may take the form of public address devices in conjunction with sirens or roving patrol cars. Both alert systems should be tested at regular intervals and a program should be undertaken to inform nearby residents as to the significance of the alert system.
